ANNUAL REPORT FOR 2011

**Bald Creek Site #1 Mitigation Site
Yancey County
TIP No. R-2518B**

Prepared By:
Natural Environment Unit & Roadside Environmental Unit
North Carolina Department of Transportation
December 2011

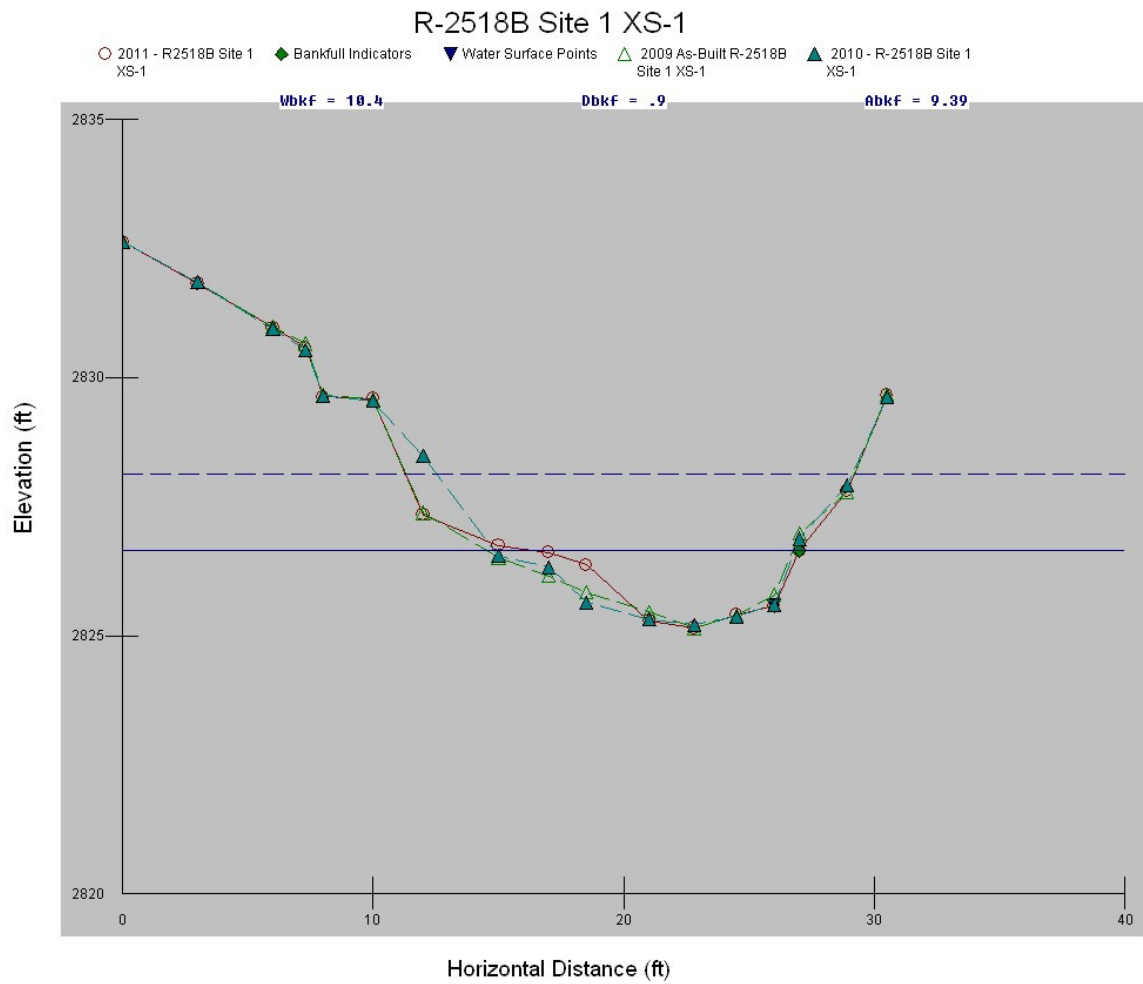
Site #1: Cross-Section #1 (Riffle) Abbreviated Morphological Summary					
	2010	2011	2012	2013	2014
Bankfull Cross Sectional Area (ft ²)	14.15	9.39			
Maximum Bankfull Depth (ft.)	1.67	1.49			
Width of the Floodprone Area (ft.)	17.62	17.88			
Bankfull Mean Depth (ft.)	1.13	0.9			
Width/Depth Ratio	11.07	11.59			
Entrenchment Ratio	1.41	1.71			
Bankfull Width (ft.)	12.51	10.43

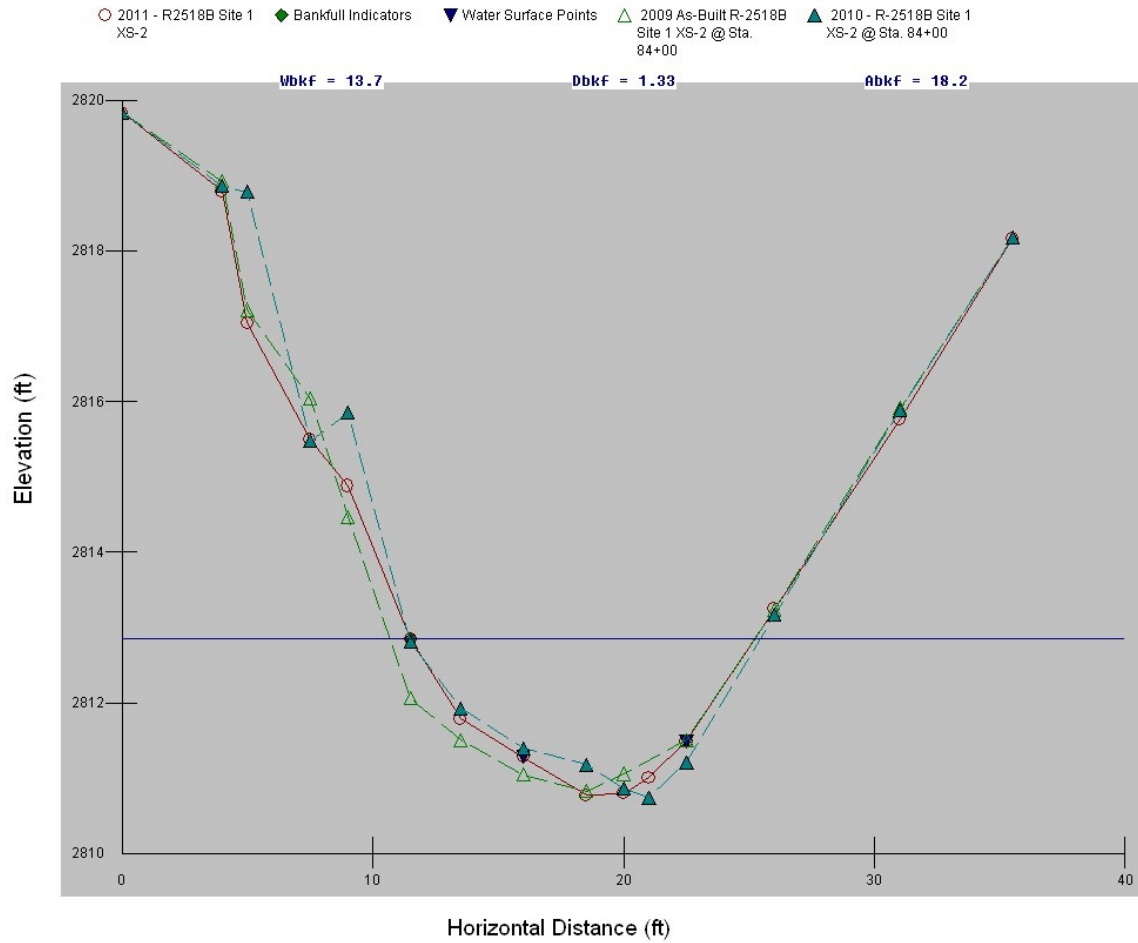
R-2518B Site 1 XS-2 @ Sta. 84+00

Site #1: Cross-Section #2 (Pool) Abbreviated Morphological Summary					
	2010	2011	2012	2013	2014
Bankfull Cross Sectional Area (ft²)	17.28	18.19			
Maximum Bankfull Depth (ft.)	2.07	2.08			
Bankfull Mean Depth (ft.)	1.25	1.33			
Bankfull Width (ft.)	13.86	13.7

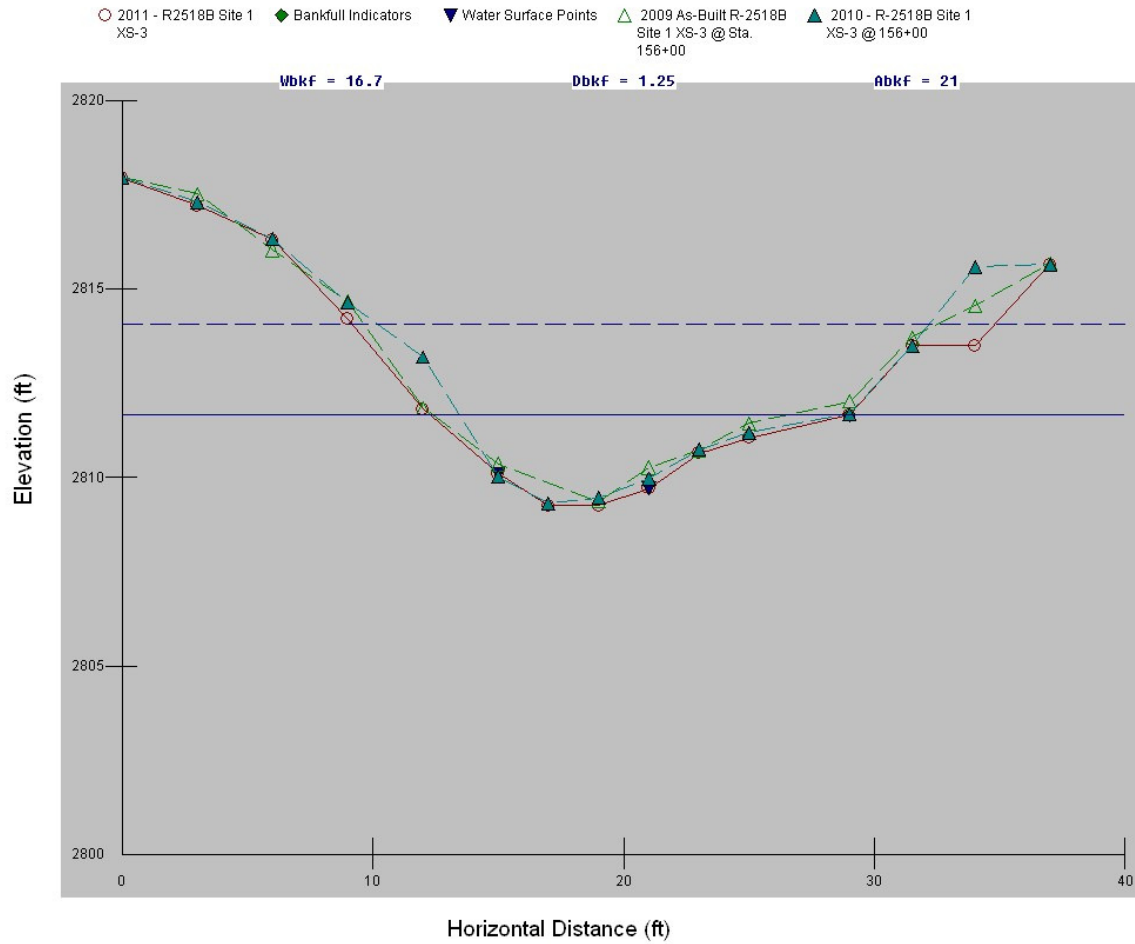
R-2518B Site 1 XS-3 @ Sta.156+00

Site #1: Cross-Section #3 (Riffle) Abbreviated Morphological Summary					
	2010	2011	2012	2013	2014
Bankfull Cross Sectional Area (ft ²)	19.03	20.99			
Maximum Bankfull Depth (ft.)	2.37	2.4			
Width of the Floodprone Area (ft.)	21.98	25.58			
Bankfull Mean Depth (ft.)	1.22	1.25			
Width/Depth Ratio	12.77	13.39			
Entrenchment Ratio	1.41	1.53			
Bankfull Width (ft.)	15.58	16.74

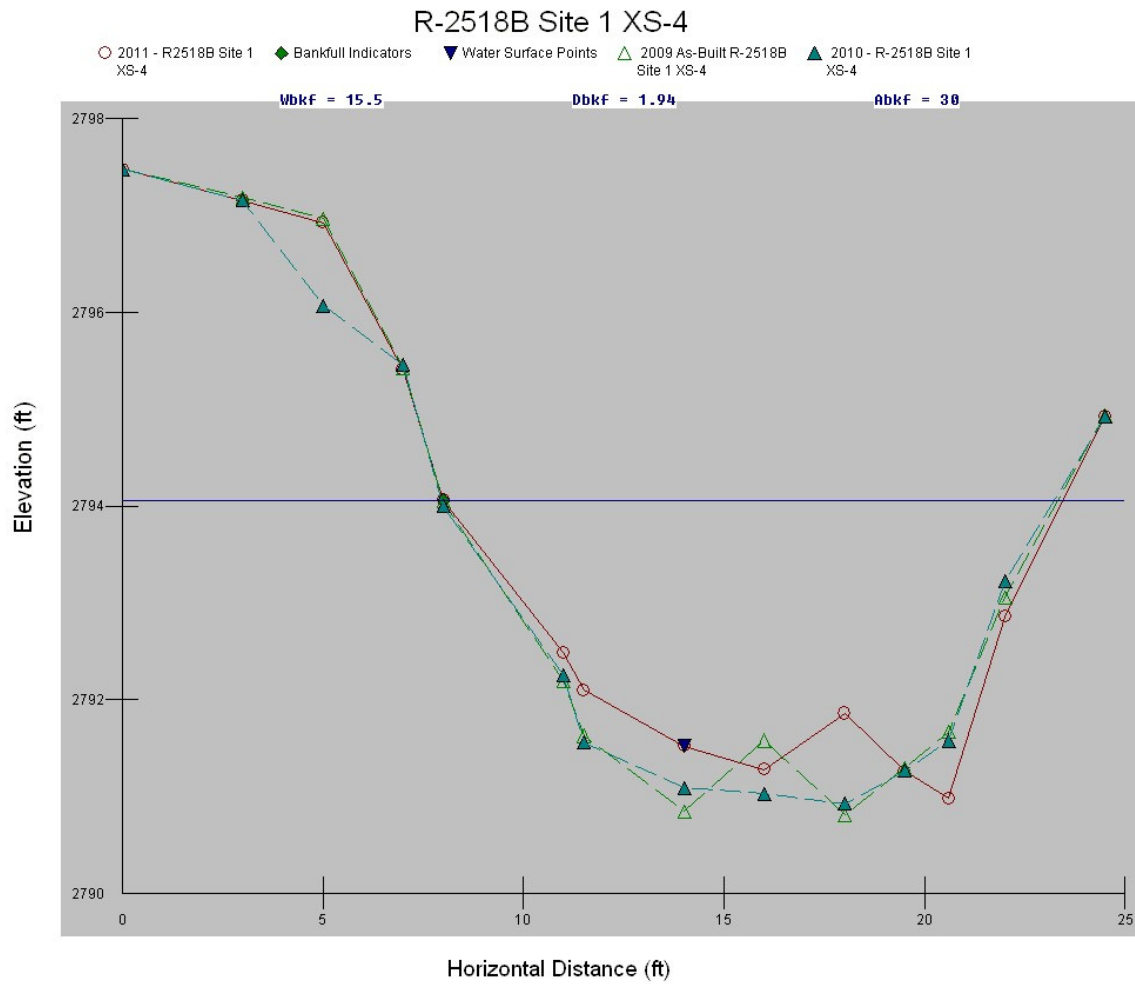
Site #1: Cross-Section #4 (Pool) Abbreviated Morphological Summary					
	2010	2011	2012	2013	2014
Bankfull Cross Sectional Area (ft ²)	32.13	30.18			
Maximum Bankfull Depth (ft.)	3.07	3.08			
Bankfull Mean Depth (ft.)	2.12	1.92			
Bankfull Width (ft.)	15.15	15.73
